**41 St. Giles'
Conservation Plan**

Building No. 232
August 2012

Oxford University
Estates Services
First draft August 2012

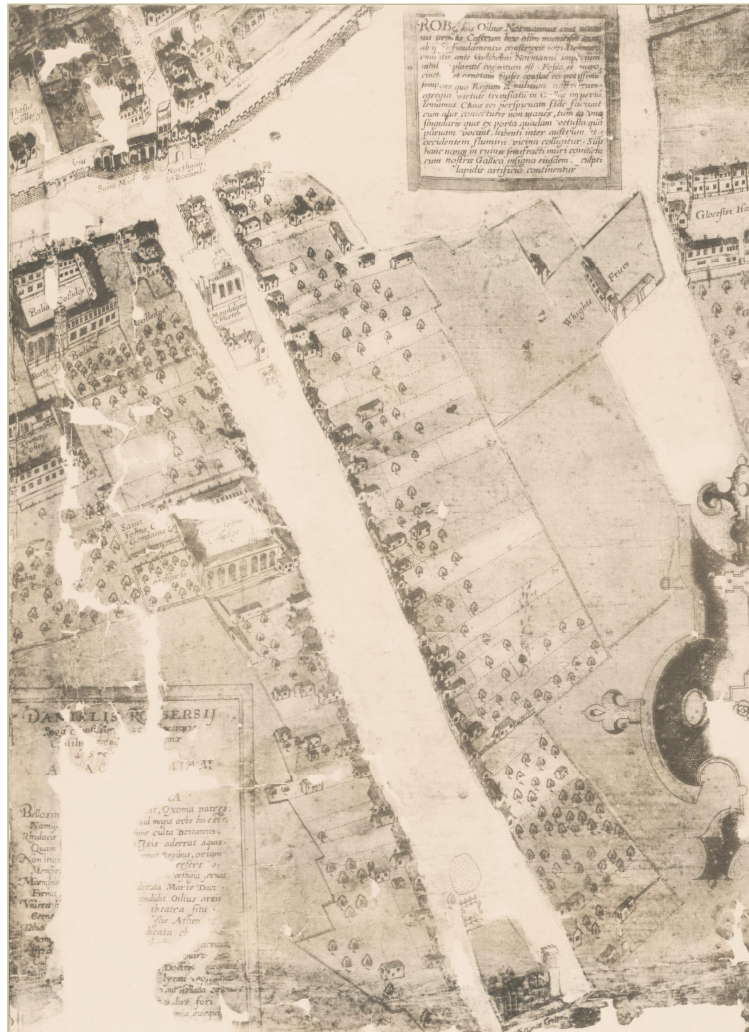
Figure 2. Detail from 1588 engraving of Agas's 1577 map of Oxford. St. Giles' with North at the bottom of the image

and outside of the main urban core housing was spaced out with abundant vacant plots (**Figure 2**). Collegiate buildings were constructed along St. Giles' in the 16th century. The Cistercian St. Bernard's College had been founded on the eastern side of the street in 1437 but it was dissolved c.1542. St. John's College took over the site in 1555 and soon expanded. There was a large gravel quarry pit in what would become St. John's College's North Quadrangle in the 16th-17th century.⁵

41 St. Giles' is constructed on a site that was extensively occupied in the mediaeval and post-mediaeval periods (**Figures 2 and 3**) and it is within Oxford City Council's City Centre Archaeology Area. Occupation on the site can be traced at least to the 12th century and there may well have been a Saxon burh in the vicinity, though this has yet to be definitively shown.³⁵ It is likely that there is significant archaeological material, with potential evidential value, preserved on the site, especially beneath the garden.

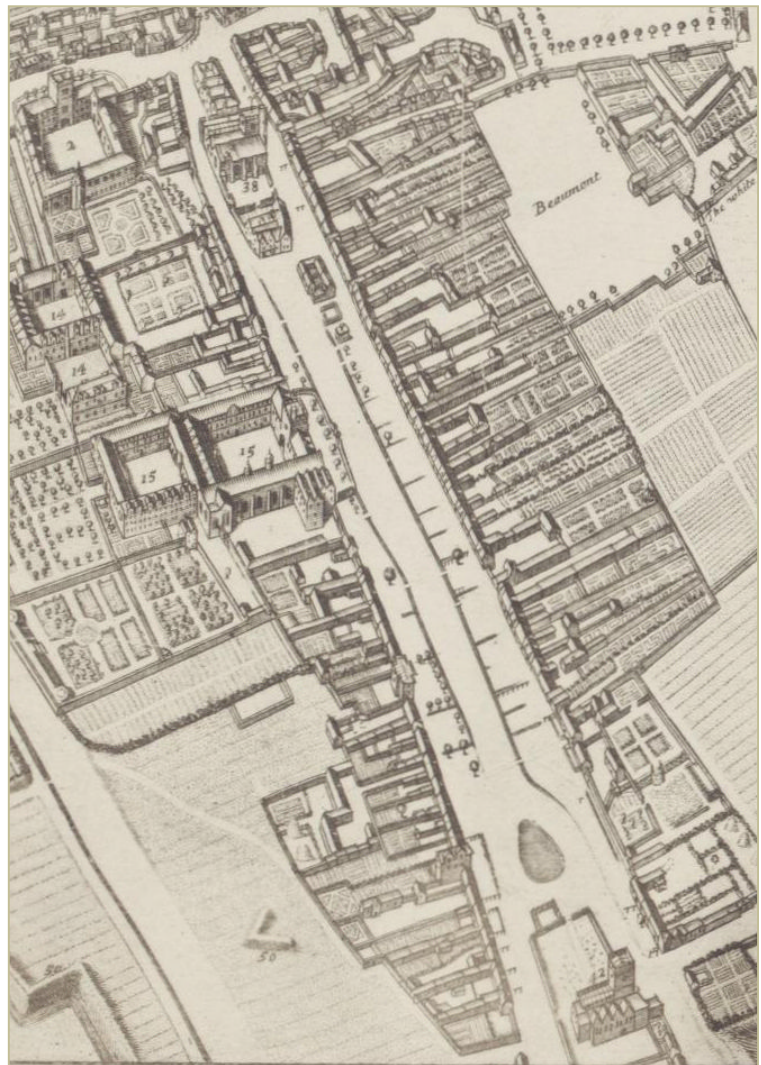
Figure 3. Detail from Logan's 1675 map of Oxford. St. Giles' with North at the bottom of the image

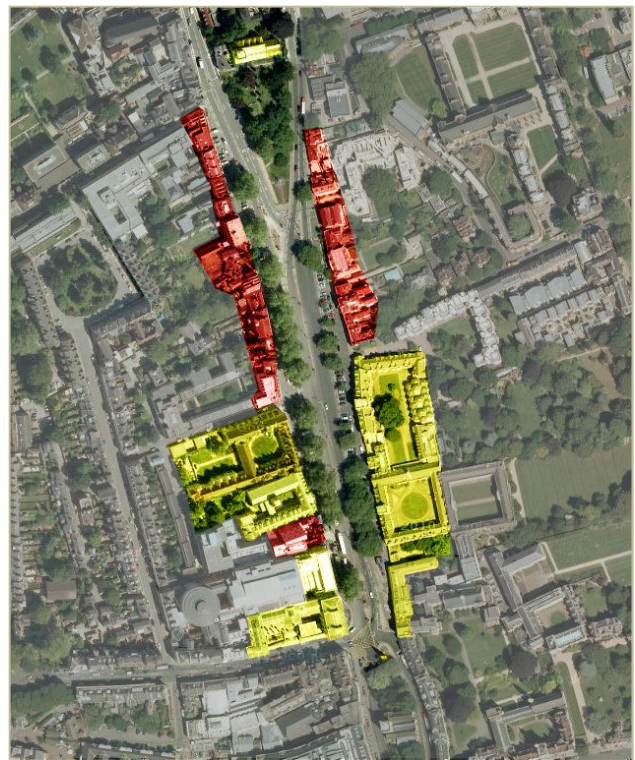
Figure 8. St. Giles’ orientated with north at the top of the image. Construction of a residential or commercial character is highlighted in red. Institutional and monumental construction is highlighted in yellow

41 St. Giles’ is an important contributory factor in the character of the northern end of St. Giles’. St. Giles’ is a wide, busy road, providing access to Oxford’s main north-south arterial roads: Woodstock Road and Banbury Road. It is made up of a combination of 18th- and 19th-century houses, institutional buildings, and 19th-century monumental construction (**Figure 8**; though almost all the buildings now have an institutional or commercial function).

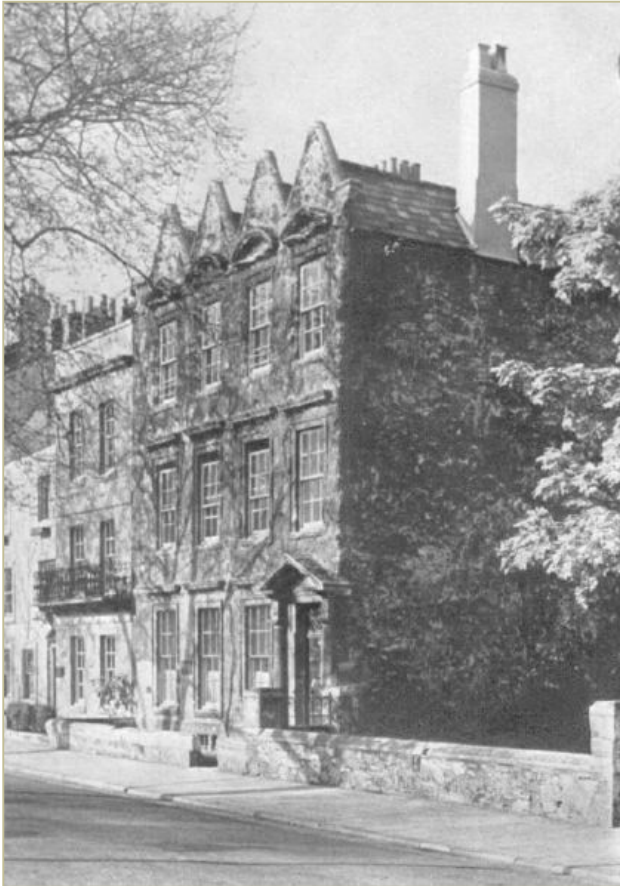
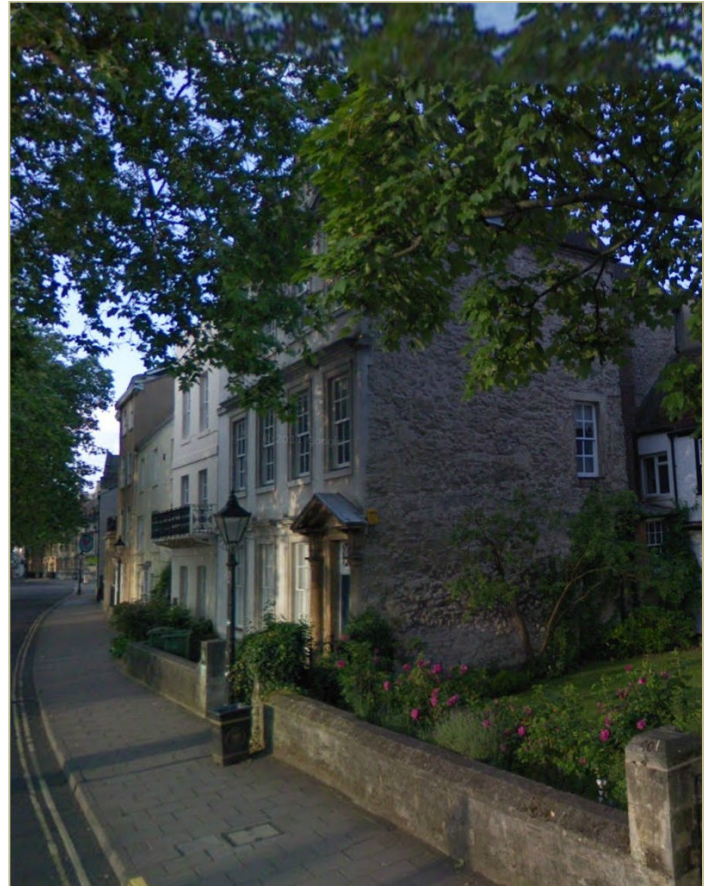
Figure 9. Left, 41 St. Giles' immediately prior to its refacing in 1956. Right, 41 St. Giles today

The St. Giles' façade was completely refaced in 1956 (**Figure 9**) in Portland stone, whilst the northern elevation was at least cleaned. The refacing was to match existing, restoring all the hard angles of the original façade. The front boundary wall was replaced with the extant wall following the same layout, but somewhat higher than the older wall and with added gateposts.

An older front wall was replaced in the same position by the current, higher wall during the 1956 refacing.³⁰ This wall is not of the same quality of the building's façade or the adjacent boundary wall of No.40 and does detract a little from the character of the setting as do the large green bins stored in the front yard. Other than the new wall and the lamppost outside, the exterior of No.41 and its immediate setting has remained unchanged since at least prior to 1956 (**Figure 9**).

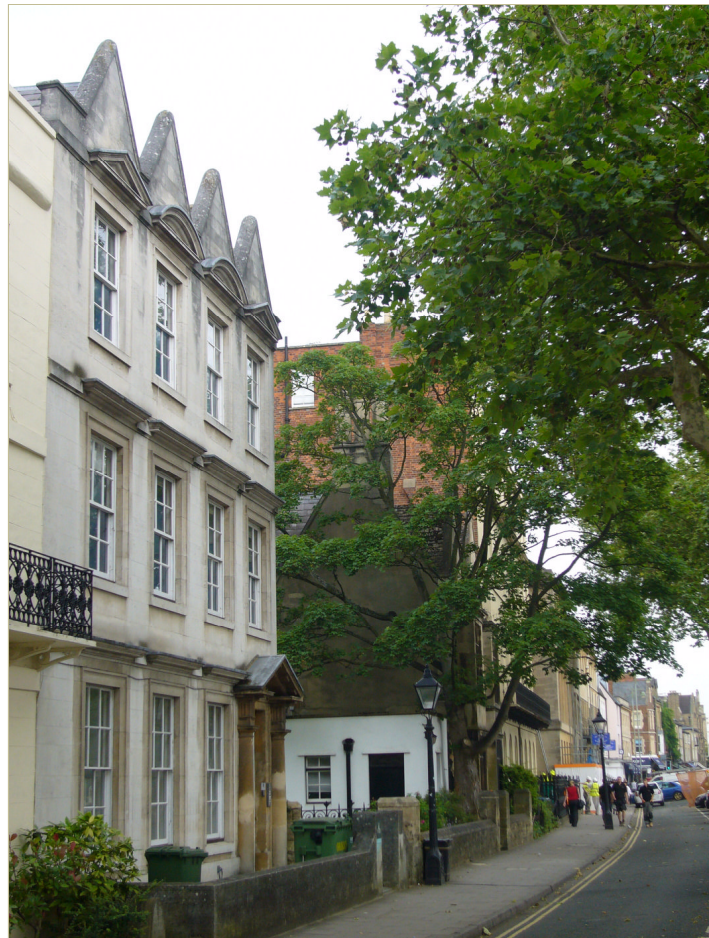
Figure 10. The façade of 41 St. Giles’ looking northwest

‘Circa 1700. 3-storeyed ashlar front with 4 gables, refaced 1956. The ground floor has 3 sash windows in moulded stone frames with moulded cornices. The front doorway to the North has two engaged Doric columns, entablature, a split pediment and a rectangular fanlight. The four sash windows in the 1st and 2nd floors have moulded cornices and the two outside windows in the latter floor have triangular pediments, while the two inside ones have segmental pediments. At the back the North West wing is probably contemporary and is partly timber-framed.’³¹

A 1926 schedule of the building described it as having ‘...an elevation of the late Jacobean Period, with the Porch a Georgian addition.’³² This suggests that the frontage was thought to be original. The 1939 Royal Commission on Historical Monuments offered a similar opinion, though placing the construction later, c.1700.³³ The Royal Commission dates the construction of the west wing as contemporary

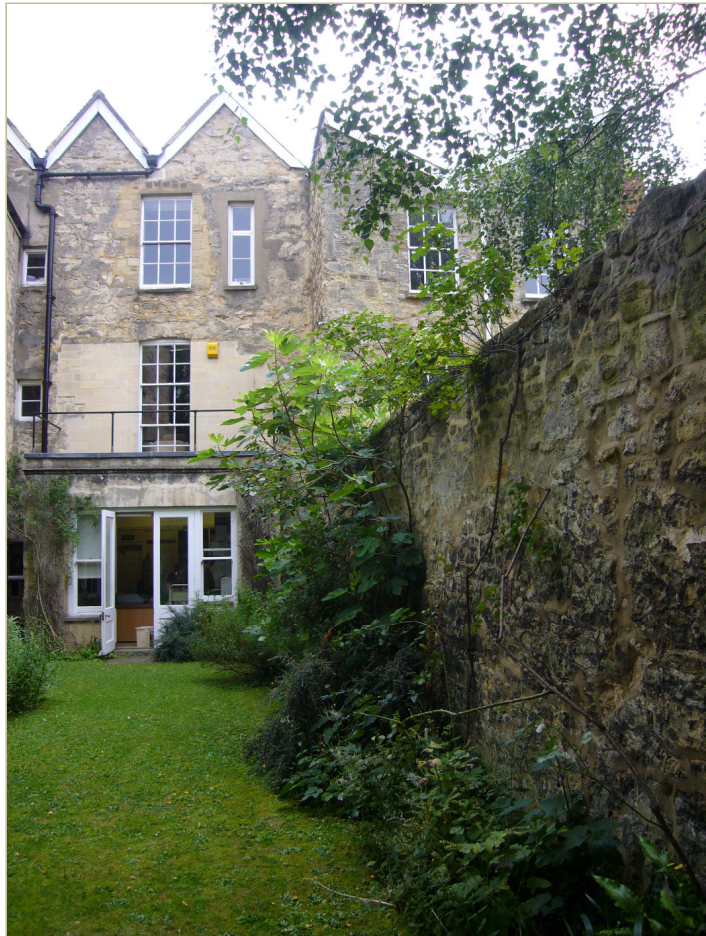
Figure 11. The rear elevation and garden wall

The rear elevations are pleasant. They were not refaced when the front was in 1956 and so display more patching and evidence of repair. The back garden is a particularly attractive space, with some of the garden walls being original. The stretch of wall separating what was the yard of the flat from the rest of the garden is relatively modern, as is the rear wall, but otherwise the garden walls are probably of a similar age to the rest of the building.

The roof has been replaced at some point, as it is described in the 1926 schedule as slate, but is currently tiled.

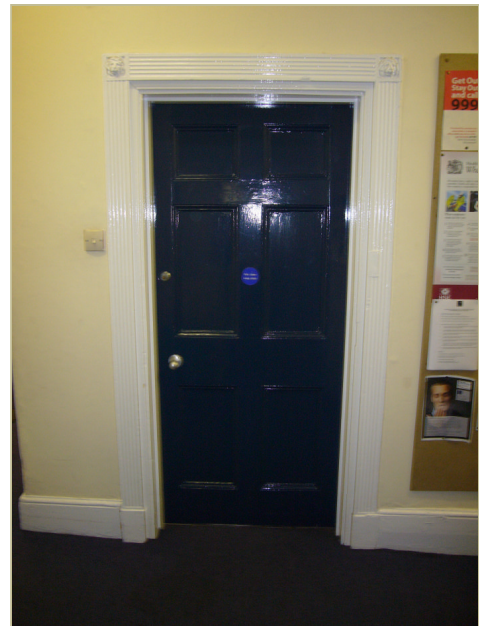
Figure 12. Door and doorcase in ground-floor hall

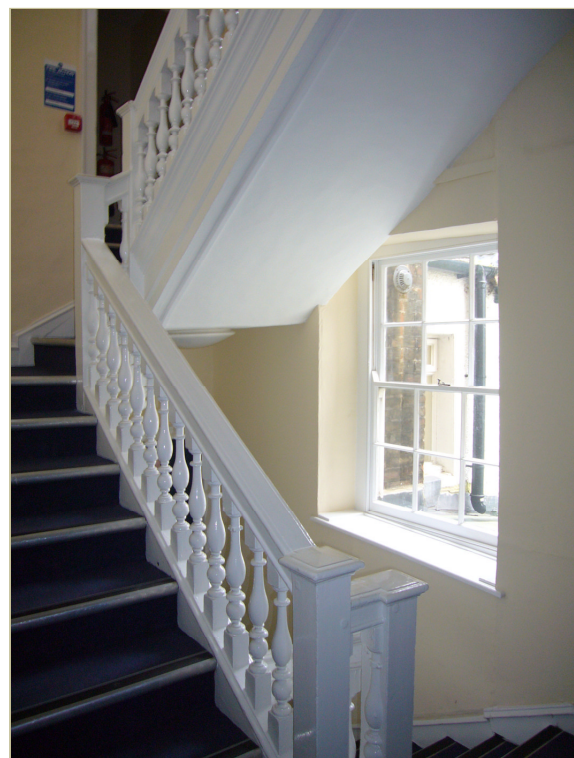
Figure 13. The staircase from the first-floor landing

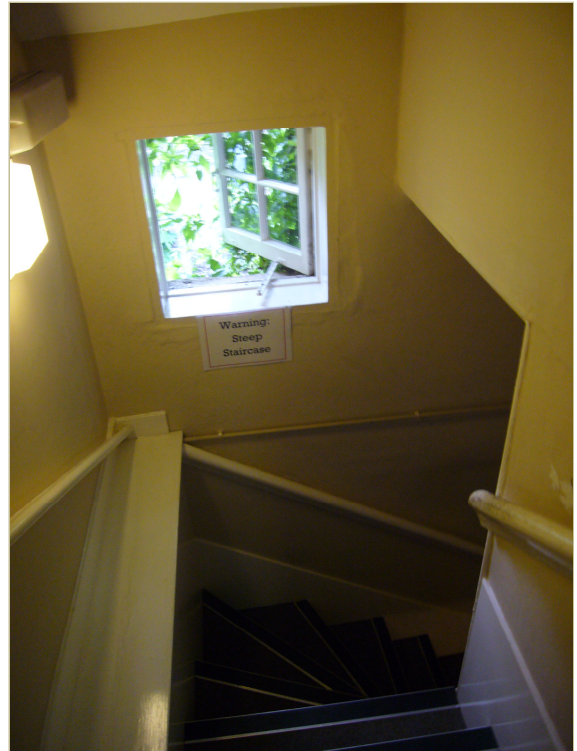
Figure 14. The staircase of the western wing

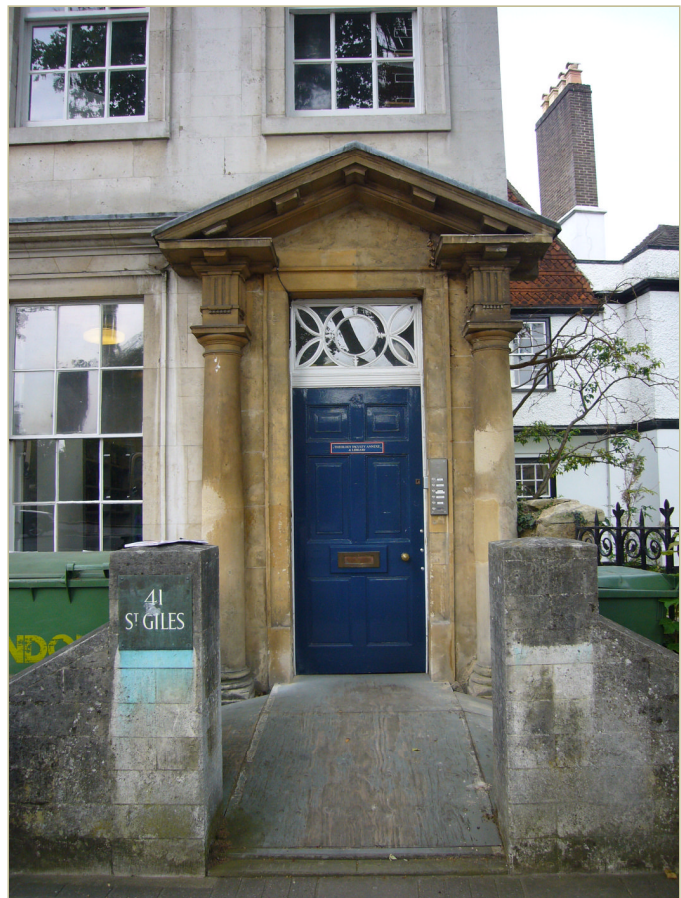
Figure 15. The main entrance from St. Giles'

The ability of 41 St. Giles' to be accessed and enjoyed by anyone who has a legitimate right to use the building is central to its significance. The significance of the heritage asset is lessened if any person who wishes to legitimately use and enjoy the building is hampered in doing so by inadequate access provision. The accessibility of the building is limited by its original design and traditional construction, though it has been fitted with an external access ramp to the front door. The front door is heavy and does not have a button-operated opening mechanism, though an intercom does allow one to call for assistance. Once within the building access between floors is by stairs only, with those to the basement being particularly narrow.

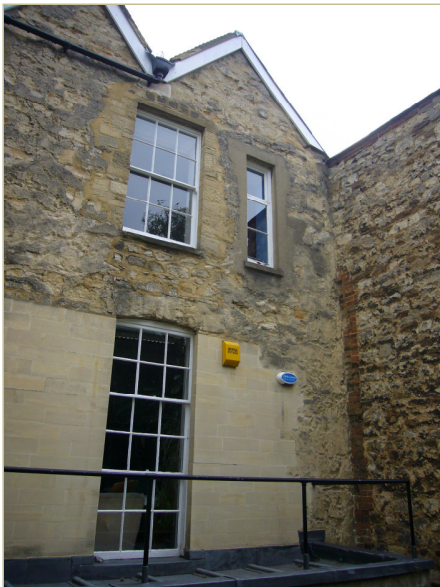
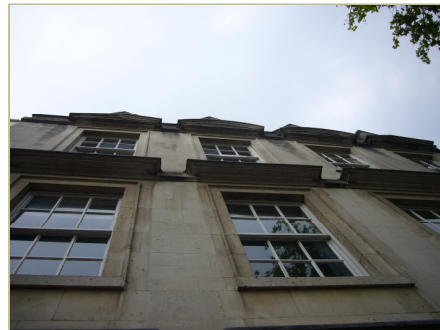
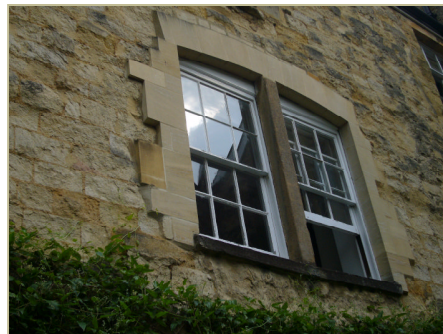
Figure 16. Left, repairs around the first-floor rear window. Top right, the St. Giles' frontage. Bottom right, repairs around the windows of the western wing

In general, the exterior has aged well due to timely repair, heavy refacing, and substantial patching; however, it remains open to weathering and erosion, potential vandalism, and pollution; damage which could detract from the significance of the heritage asset.

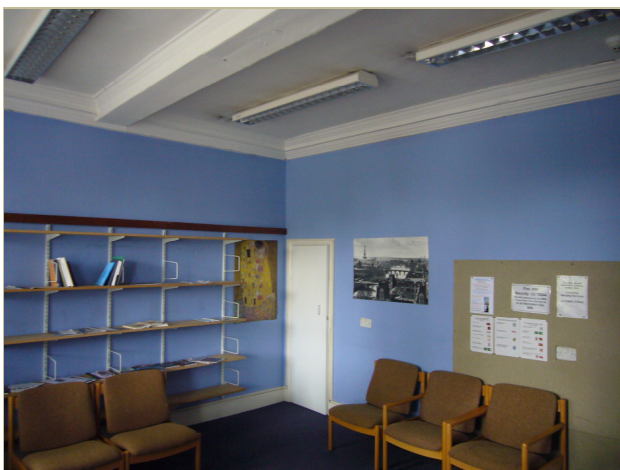
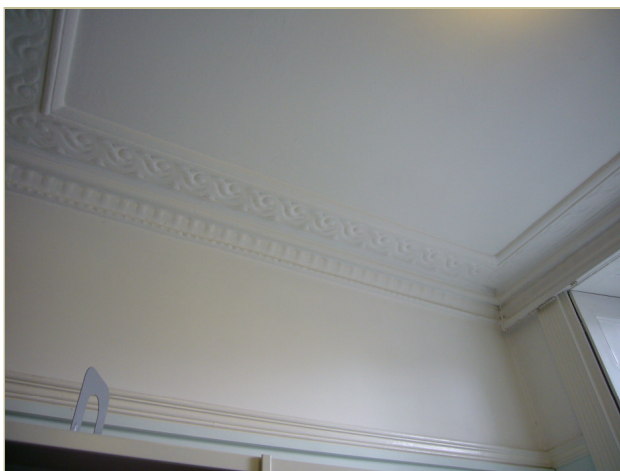
Figure 16. Top left, the utilitarian character of the first-floor common room. Bottom left, ceiling decoration in the ground-floor front room. Right, joinery on the staircase

As the interior features are in regular use and of less permanent construction than the external structure of the building, they are vulnerable to vandalism, accidents, and general wear and tear. Some of these issues should be mitigated assuming adequate security and maintenance regimes are in place, but ultimately these significant elements will have limited lifespans. These lives can be lengthened as much as possible through regular, adequate monitoring and maintenance.
